Riverfront Remediation:  
Redevelopment for Human Access and Wildlife Health

MASTER OF LANDSCAPE ARCHITECTURE

A master plan proposal for the former ARMCO Steel manufacturing site in Kansas City, Missouri to control and remove pollutants contributing to ground and water contamination.

ARMCO SITE, Kansas City, MO

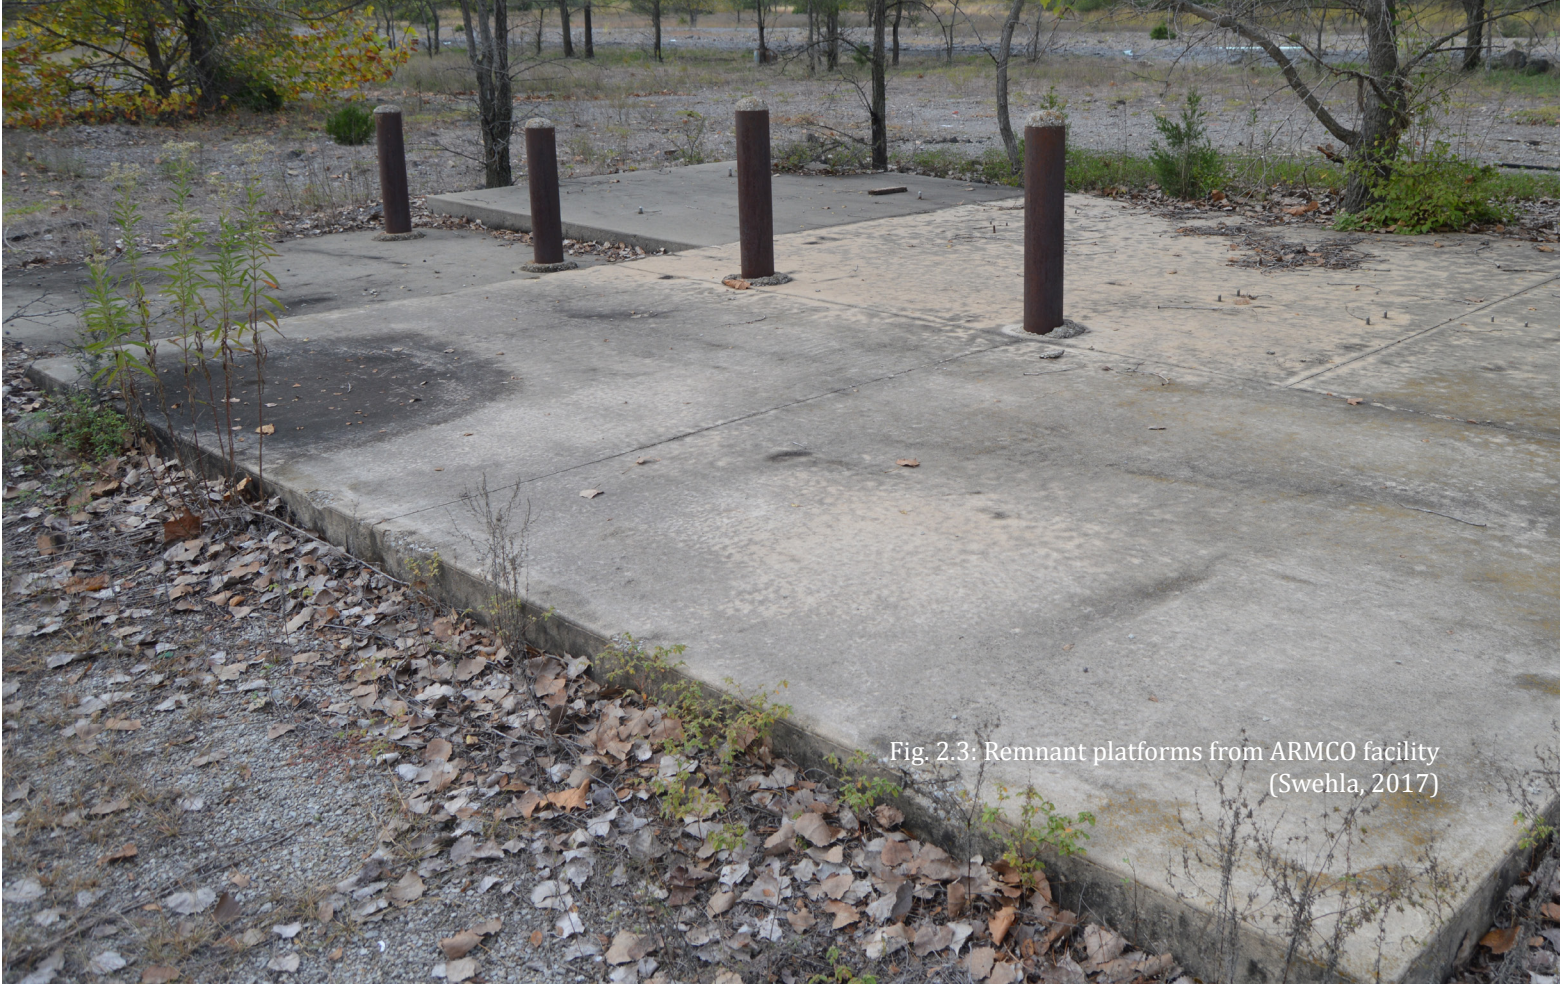
Fig. 2.3: Remnant platforms from ARMCO facility (Swehla, 2017)

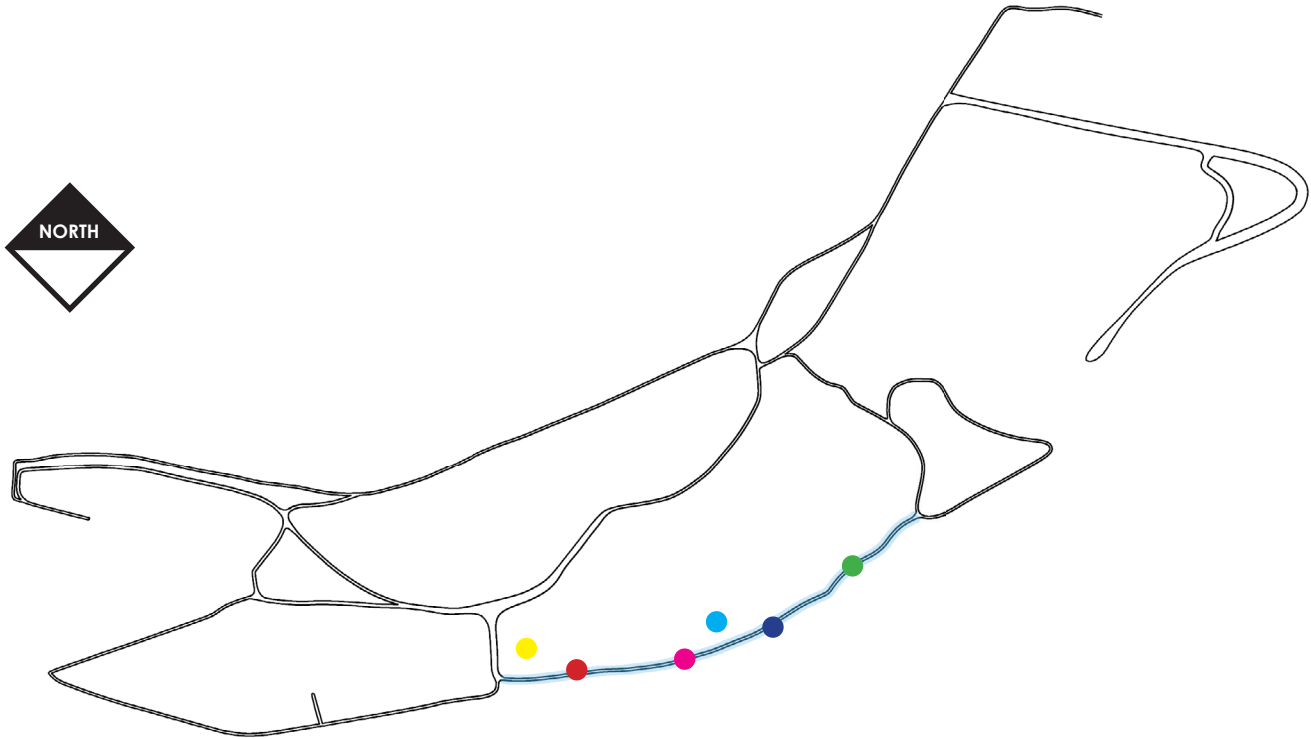
Fig. 3.8: Path Section 2 (Swehla, 2017)

This area of the pathway is similar to the previous section. The path is gravel, partially overgrown with short grass. Further down the trail, however, the grass pathway turns entirely to gravel. In the gravel paved sections of this path there were sightings of animal tracks, like deer, goose, and turkey. There are telephone lines crossing the path midway which continue into the site. On the southern boundary, there is a channel

collecting water that feeds Rock Creek, and a steep incline which services the rail corridor. The vegetation lining the edges of this section vary from tall grasses to shrubs, eventually giving way to forest. The path narrows as it progresses East, funneling into the next section of trail head.

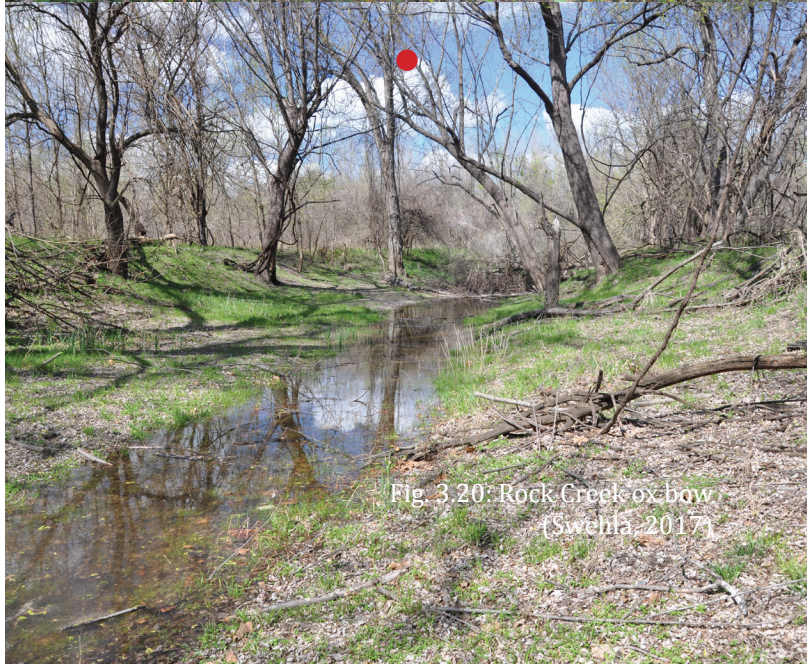
Fig. 3.20: Rock Creek ox-bow (Swehla, 2017)

The looping section of trail highlighted below is heavily vegetated. Areas of this trail require you to duck beneath tree limbs and step over fallen debris. The beginning leg of this trail is sparsely paved with loose gravel, quickly transitioning to overgrown grass. It is obvious that this beginning section is unmowed and unmaintained. The path crosses a steeply sloped, dried ox bow section of Rock Creek. Near the ox bow, warning signs are found

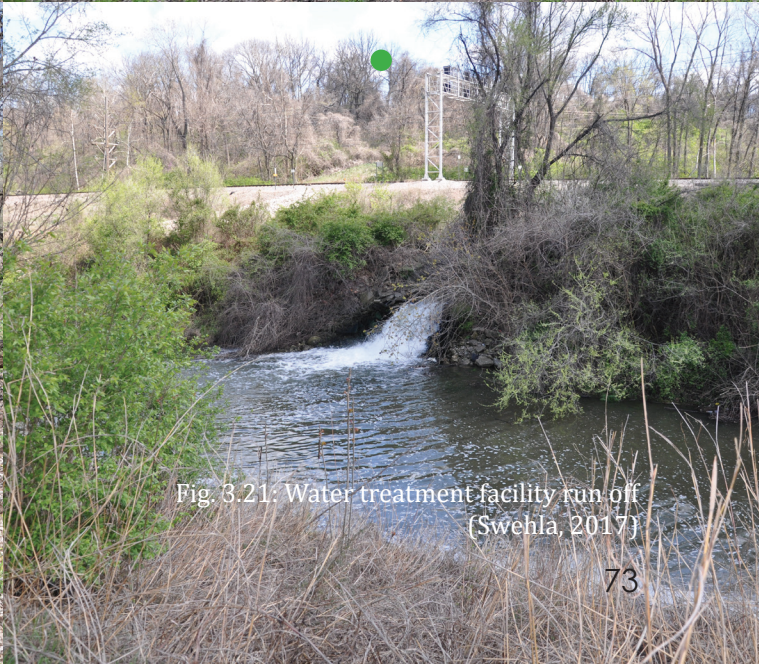
Fig. 3.21: Water treatment facility run-off (Swehla, 2017)

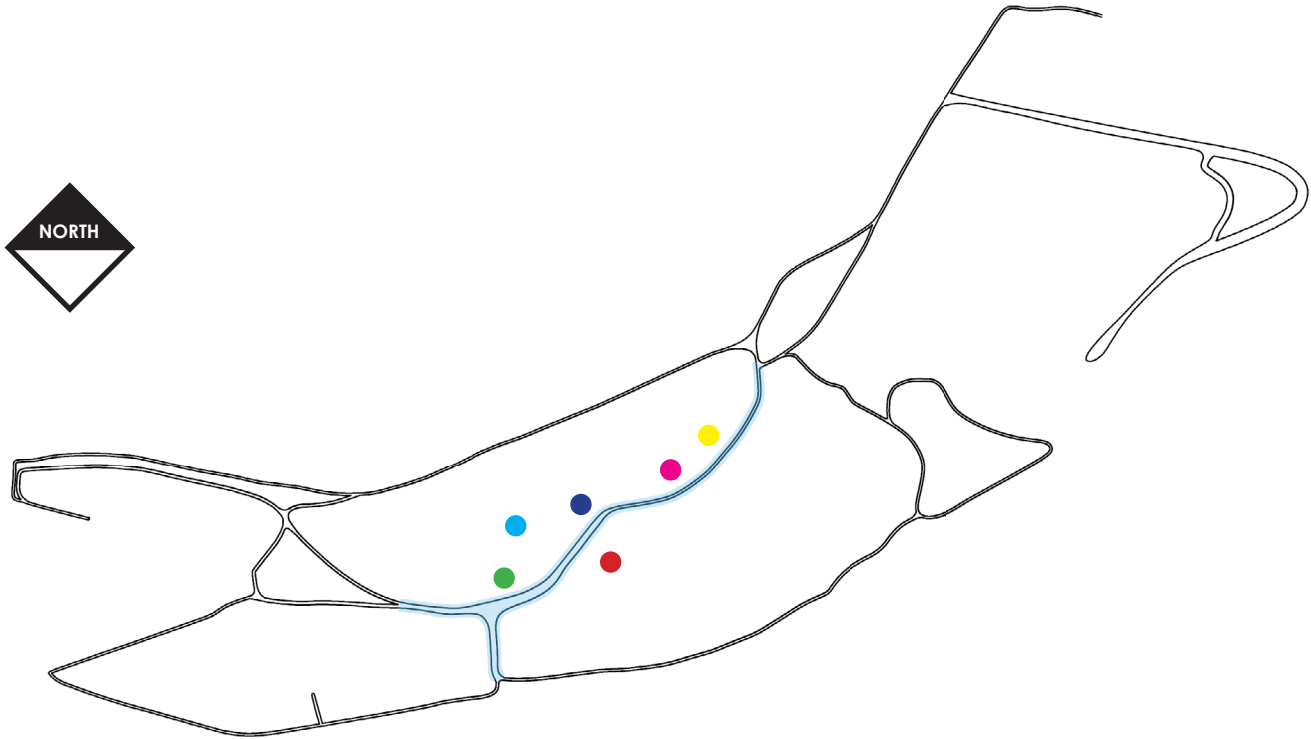
Fig. 3.22: Path Section 4 (Swehla, 2017)

One of the two landfills located at the ARMCO Site is directly adjacent to the highlighted section of gravel path below. The landfill sits slightly elevated above the pathway. North of this landfill is the former rail corridor where the ARMCO Steel Co. would import and unload their steel for manufacturing. This process left large amounts of surface debris. The soil that was excavated to cap the waste by-products left behind a shallow depression

on the North side of the landfill that collects water during flooding and rainstorms. This collection of water attracts frogs and turtles from Rock Creek and the Blue River. Vegetation near and around this path is primarily low growing, grass and shrubs.

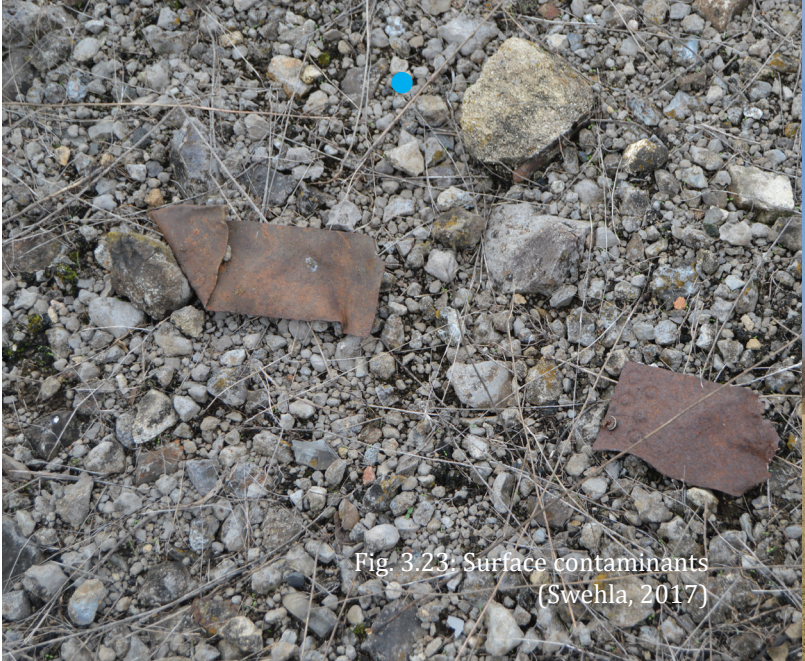
Fig. 3.23: Surface contaminants (Swehla, 2017)

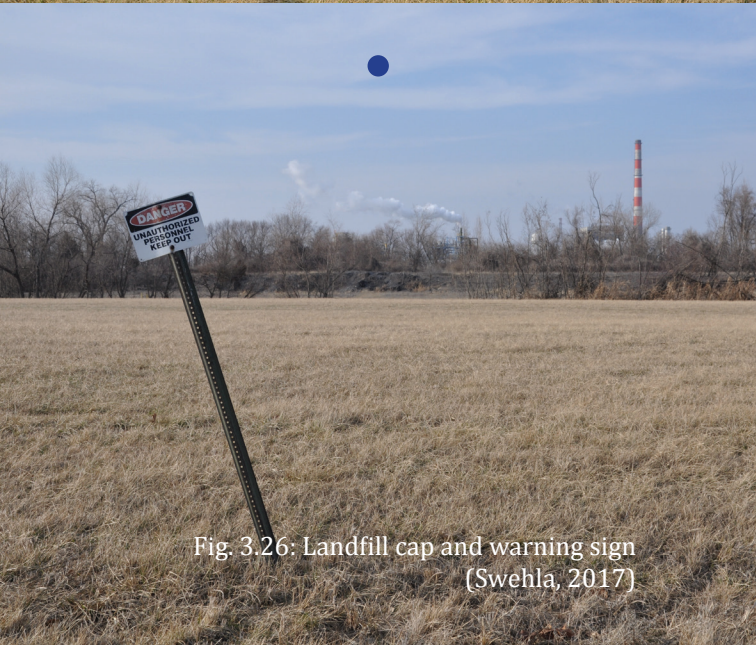
Fig. 3.26: Landfill cap and warning sign (Swehla, 2017)

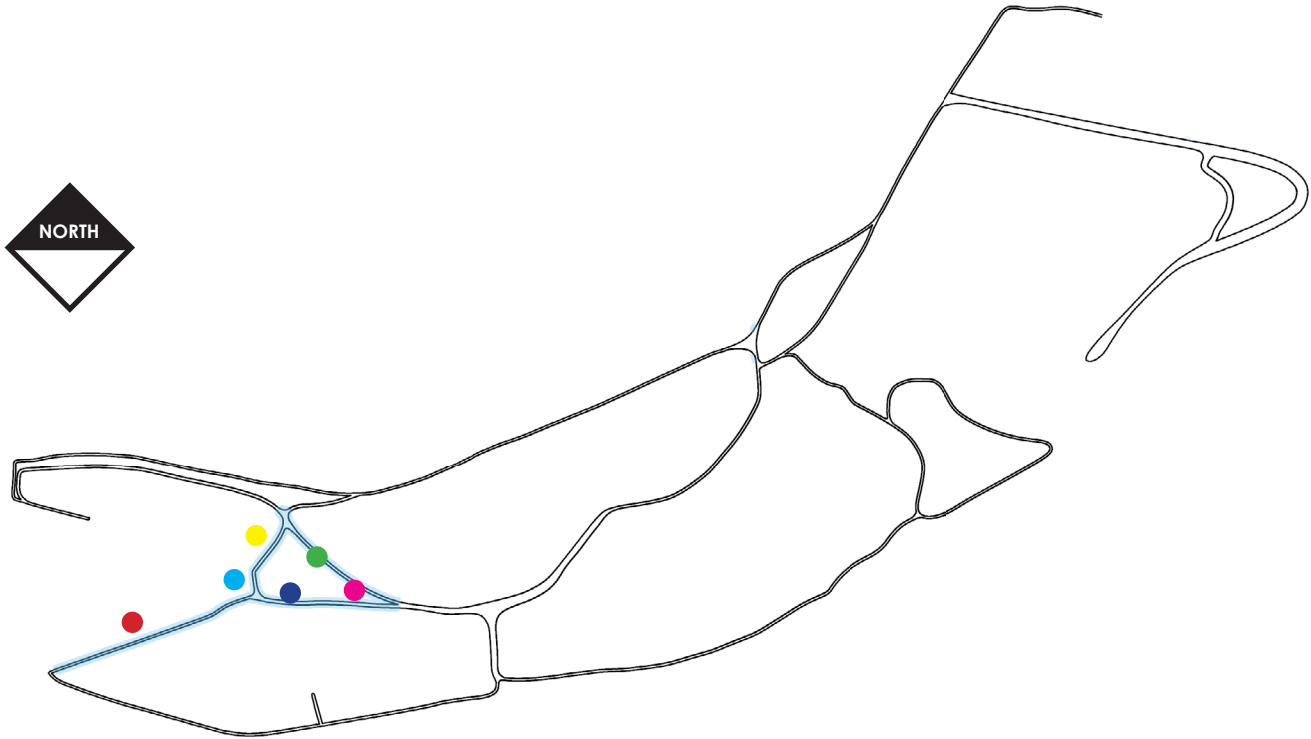
Fig. 3.29: Path Section 5 (Swehla, 2017)

This highlighted pathway provides access from the lowland area to the two landfills. The former rail corridor running through the site left a trail of metal debris on the north edge. Rainfall on the western side of the trail's fork runs west towards the existing railroad corridor, and eventually the Blue River, while rainfall on the eastern side of the trail fork deposits into Rock Creek. The area of land located inside the connected

pathway shown below is heavily vegetated, containing indiscernible concrete forms and metal debris. From this path you see the first glimpse of the West landfill and can walk along it's East edge.

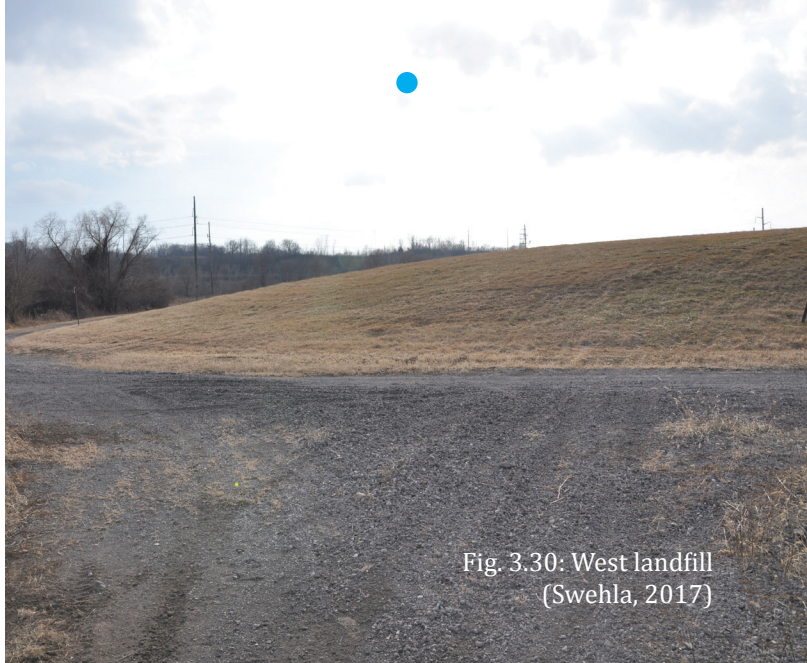
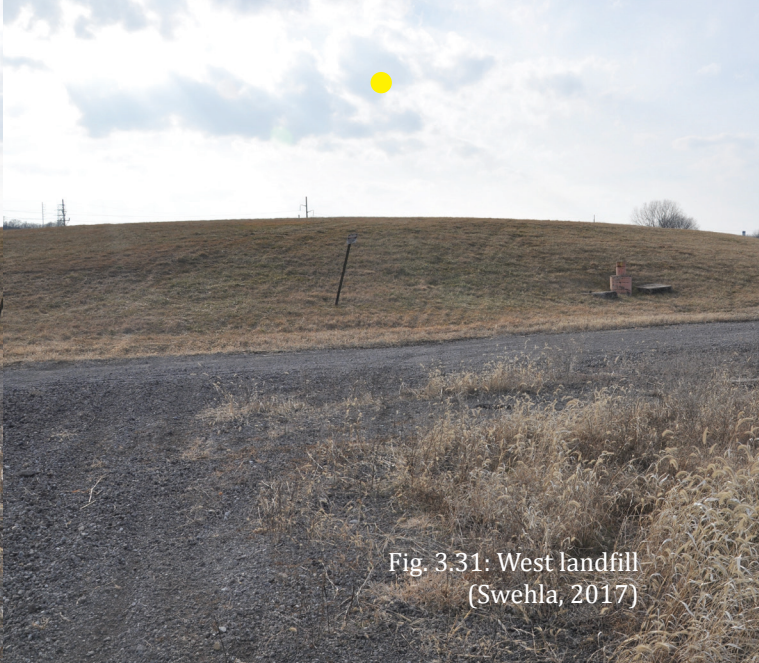
Fig. 3.30: West landfill (Swehla, 2017)

Fig. 3.31: West landfill (Swehla, 2017)

The West landfill located at the ARMC0 Site is much taller than the East landfill. The West landfill is steeply sloped on the North, East, and South sides. From the top of the landfill mound you can clearly see above the canopy of any surrounding trees. The landfill has air release valves to help relieve gaseous buildup underground. Access to the landfill mound is provided by a gravel trail running along the North and West sides. The West

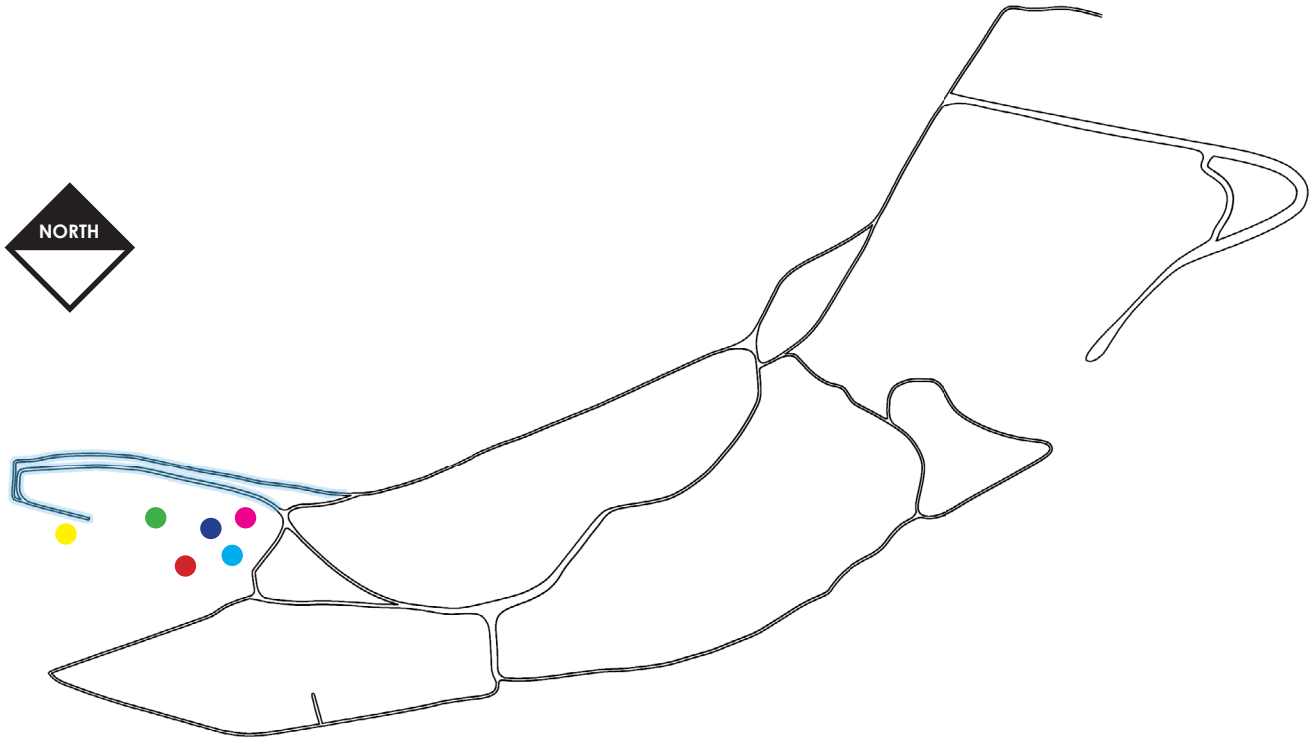
side trail is shallowly sloped, allowing a gradual summit to the top. The trail ends but transitions to short grass which is pleasant to walk upon. The size of the mound is large enough to imagine an entire soccer field atop it. Vegetation along the trail is planted short grass with very little tree growth.

Fig. 3.36: Path Section 6 (Swehla, 2017)

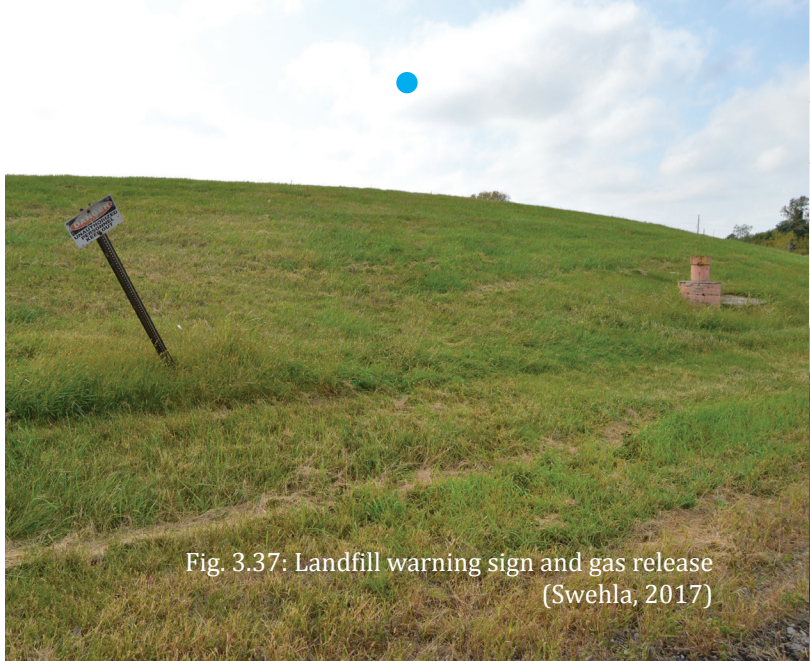
Fig. 3.37: Landfill warning sign and gas release (Swehla, 2017)

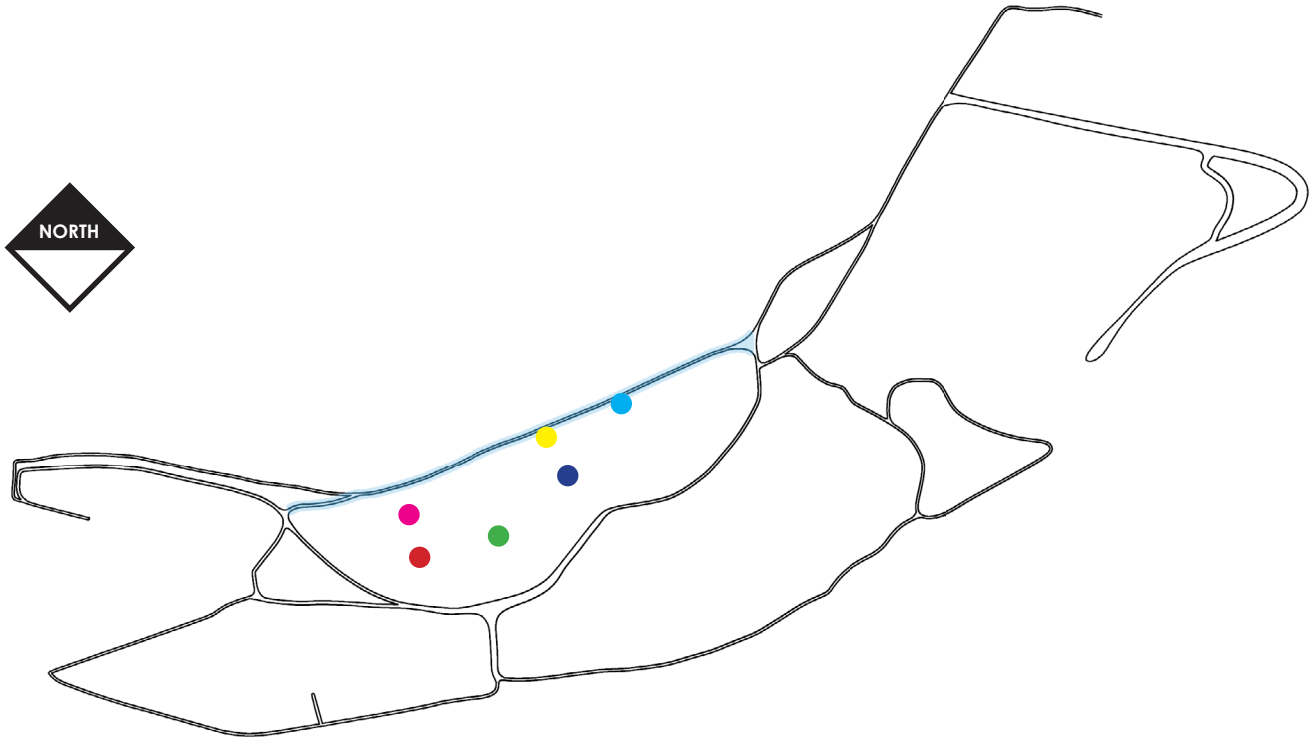
The trail section highlighted below is slightly raised above the surrounding ARMCO Site because it is on top of the flood dyke built by ARMCO Steel Co. to prevent the Blue River floodplain from expanding. Across the open area to the South of this section, the ground is littered with remnants from the ARMCO Steel Co. manufacturing business. It is clear to see where the old railroad lines came onto the site. The slab of concrete where the company

building was located is still visible. Vegetation along the flood dyke trail is lowland forests to the North. To the South, vegetation is sparse and scattered, containing grasses, shrubs, and some trees. The majority of the ground cover in the former rail corridor is not vegetative, but gravel.

Fig. 3.43: Path Section 7 (Swehla, 2017)

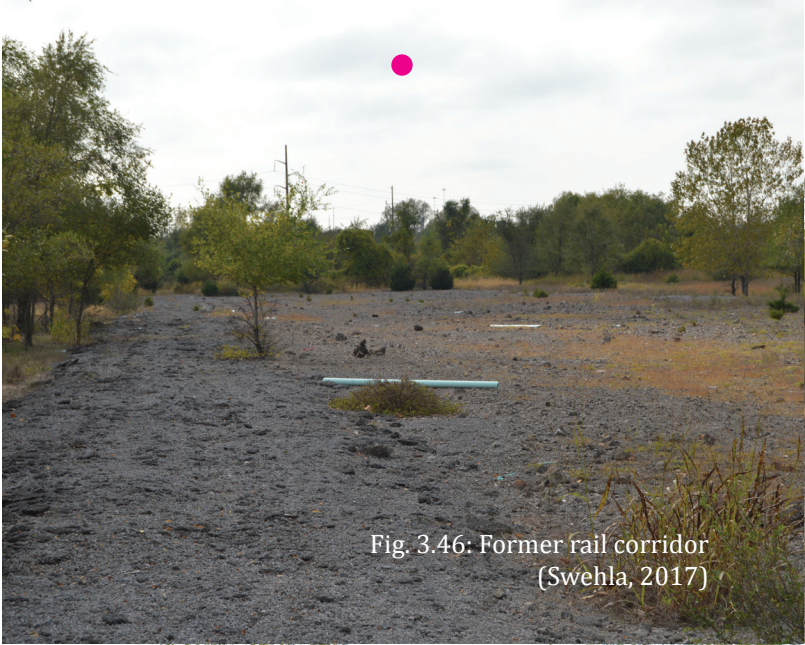
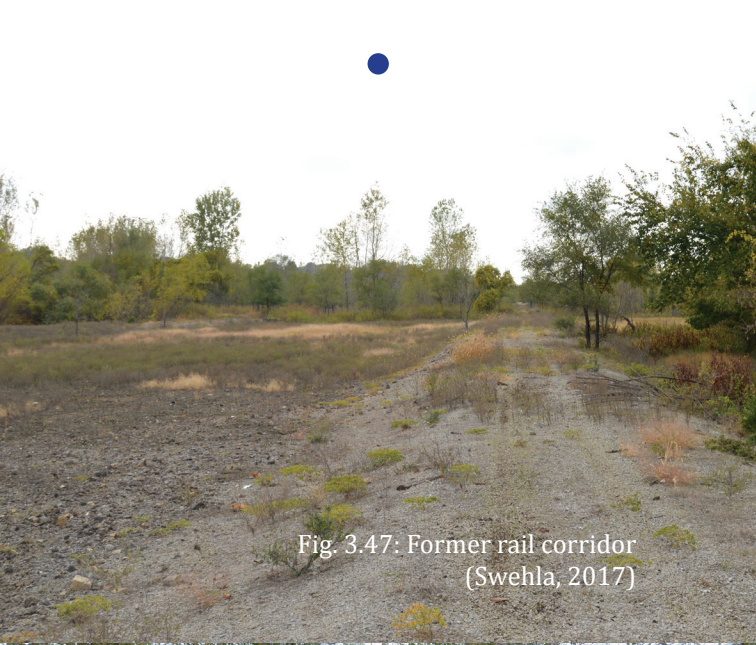
Fig. 3.46: Former rail corridor (Swehla, 2017)

Fig. 3.47: Former rail corridor (Swehla, 2017)

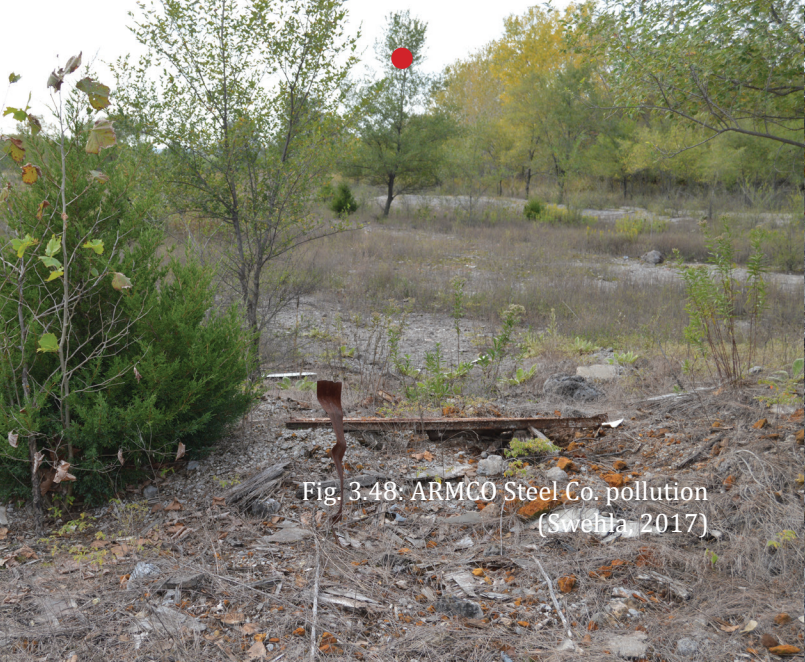
Fig. 3.48: ARMCO Steel Co. pollution (Swehla, 2017)

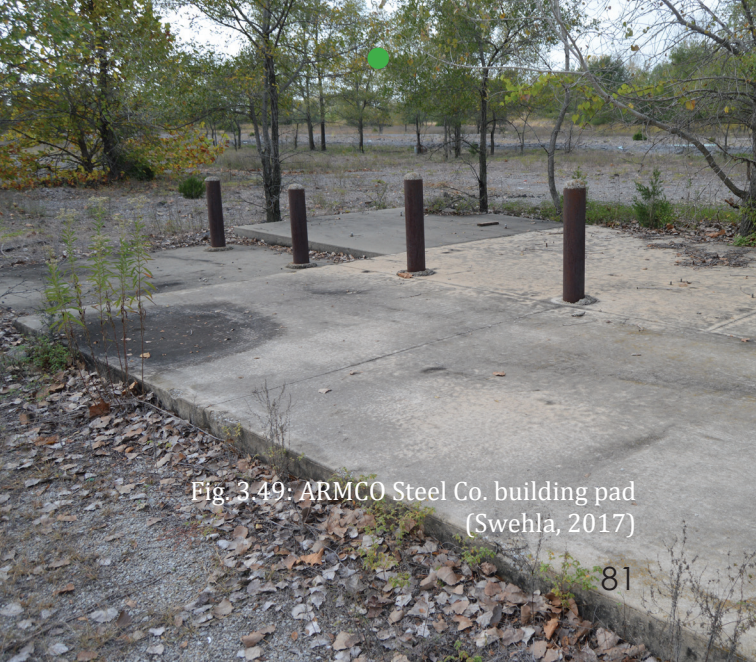
Fig. 3.49: ARMCO Steel Co. building pad (Swehla, 2017)

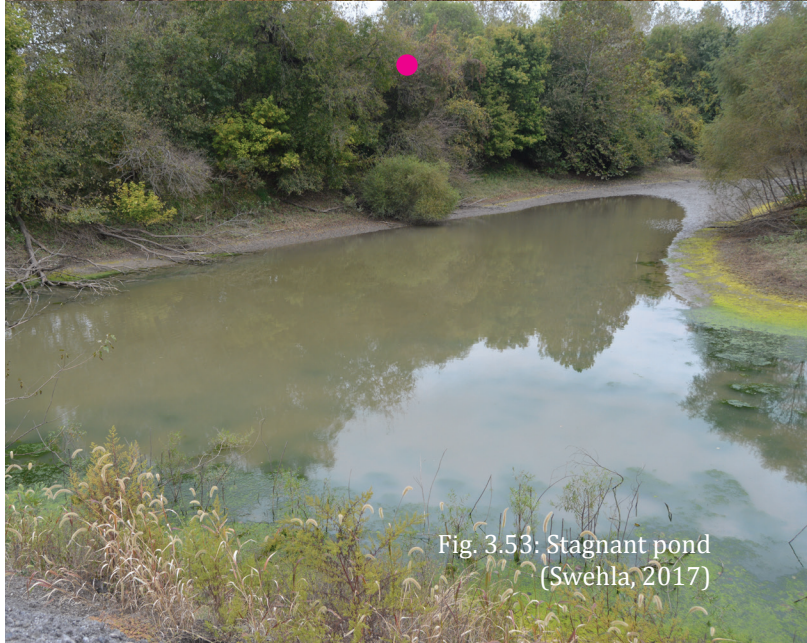
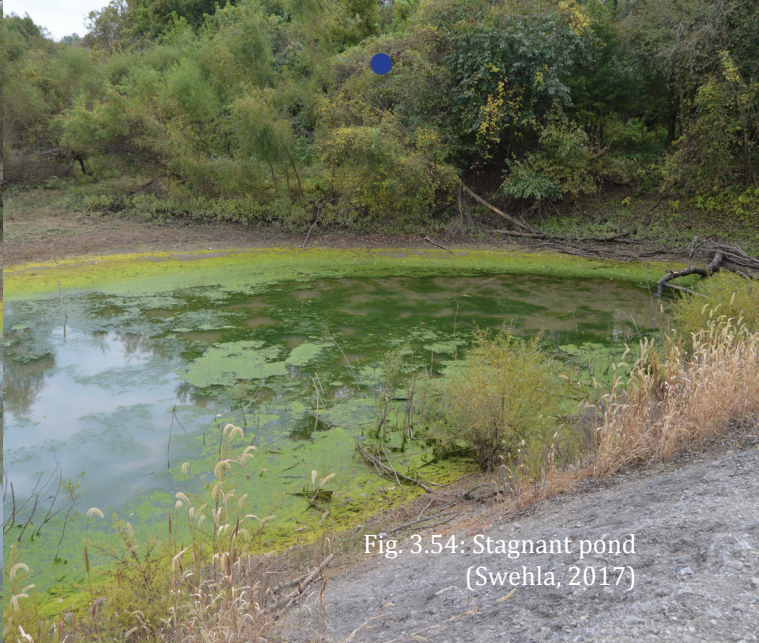
The path shown below leads towards the Missouri River. On the Southeast edge of the trail there is an accumulation of stagnant water from flooding. The depression that retains water here is a portion of the dried Rock Creek ox bow. The northwest edge of the trail is steeply sloped towards the Blue River, vegetated with lowland forest. The East side of the trail is grown over with a mixture of tall grasses and shrubs.

Fig. 3.53: Stagnant pond (Swehla, 2017)

Fig. 3.54: Stagnant pond (Swehla, 2017)

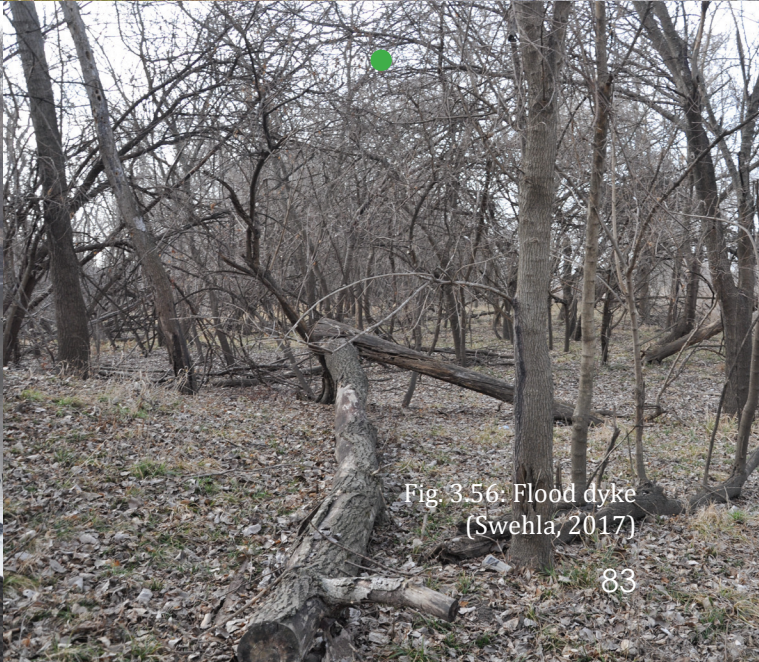
Fig. 3.56: Flood dyke (Swehla, 2017)

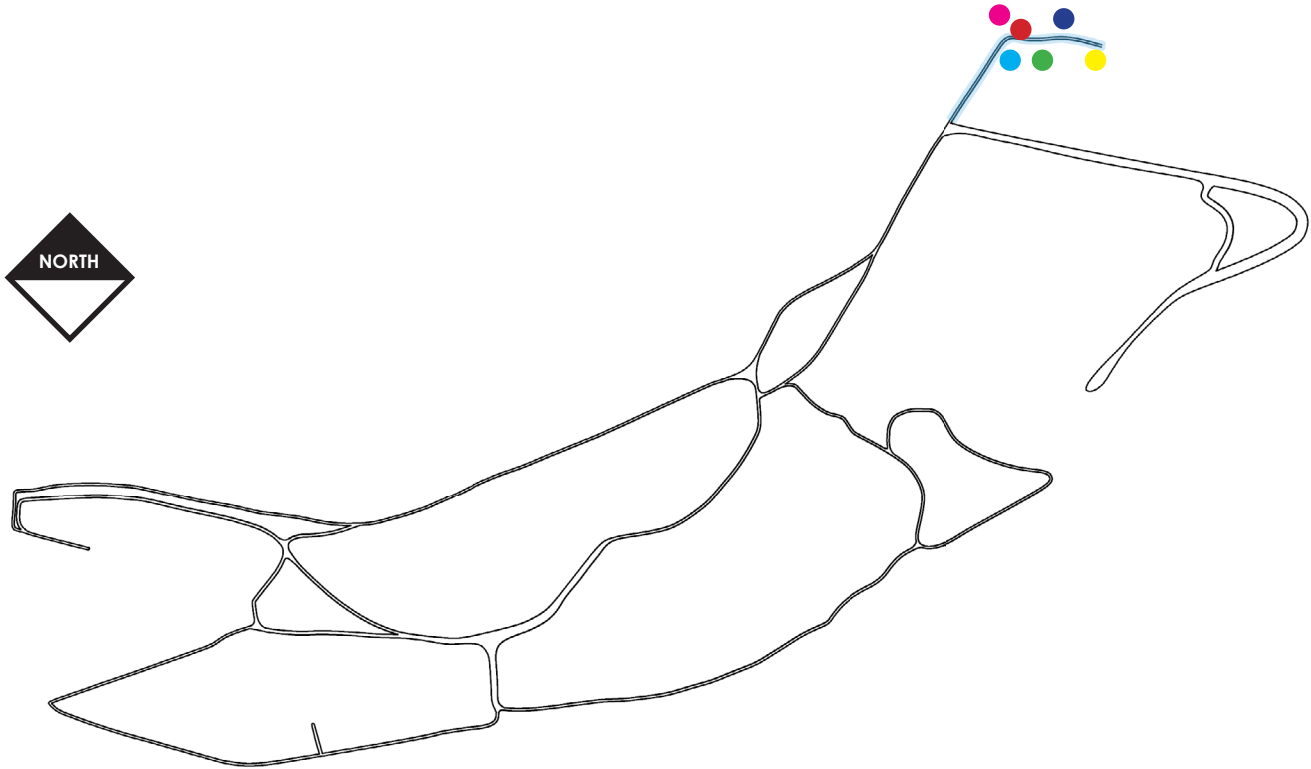
The farthest trail section is gravel paved and lined along the sides with tall grasses. The area at the end of the trail is a large prairie style opening with tall light poles illuminating the space at night. The river edge is a steep drop off into the Missouri River. At the water's edge, there is an old shipping dock. The dock is a metal structure with timber topping which has rotted through in some areas.

Fig. 3.64: Path Section 10  
(Swehla, 2017)

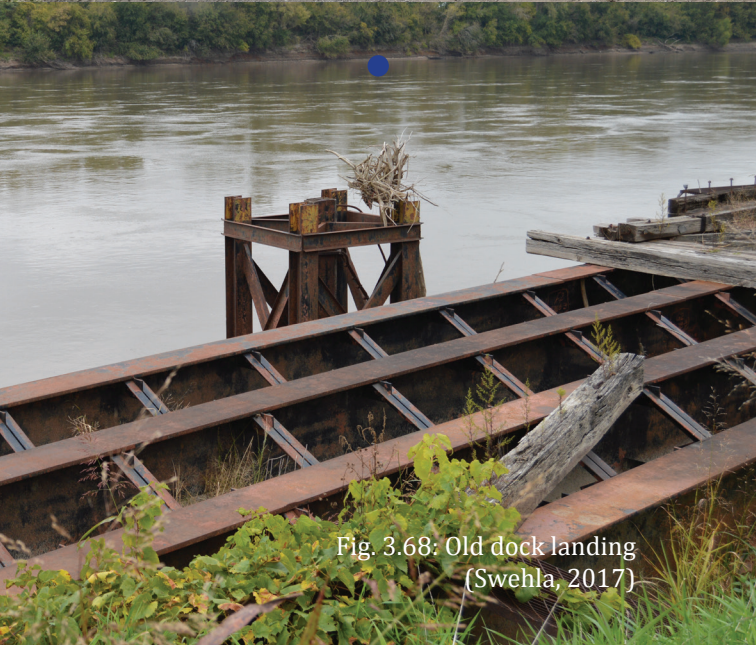
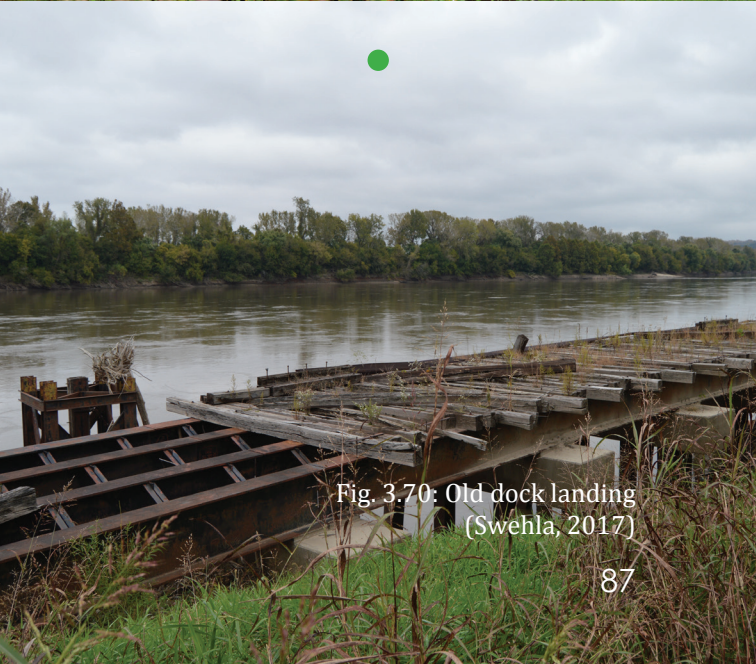
Fig. 3.68: Old dock landing  
(Swehla, 2017)

Fig. 3.70: Old dock landing  
(Swehla, 2017)

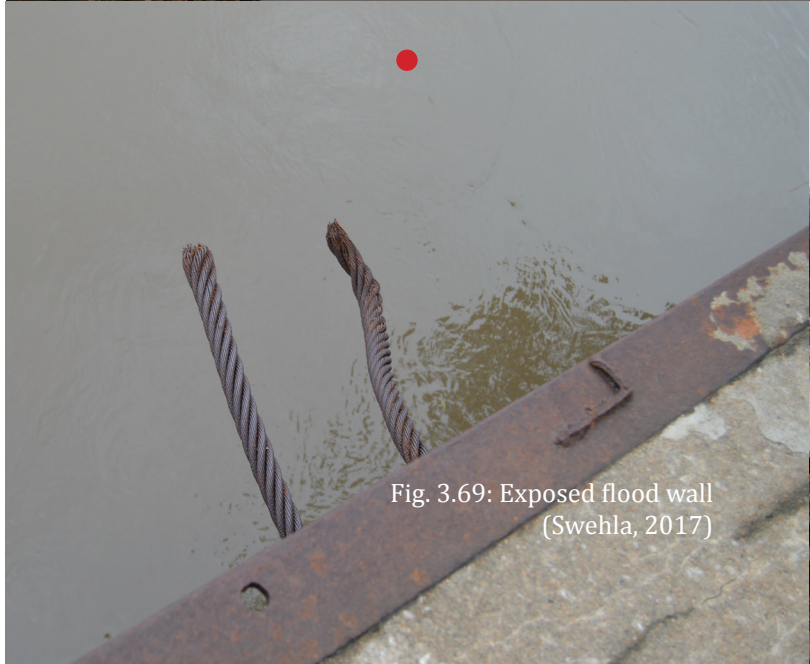
Fig. 3.69: Exposed flood wall  
(Swehla, 2017)

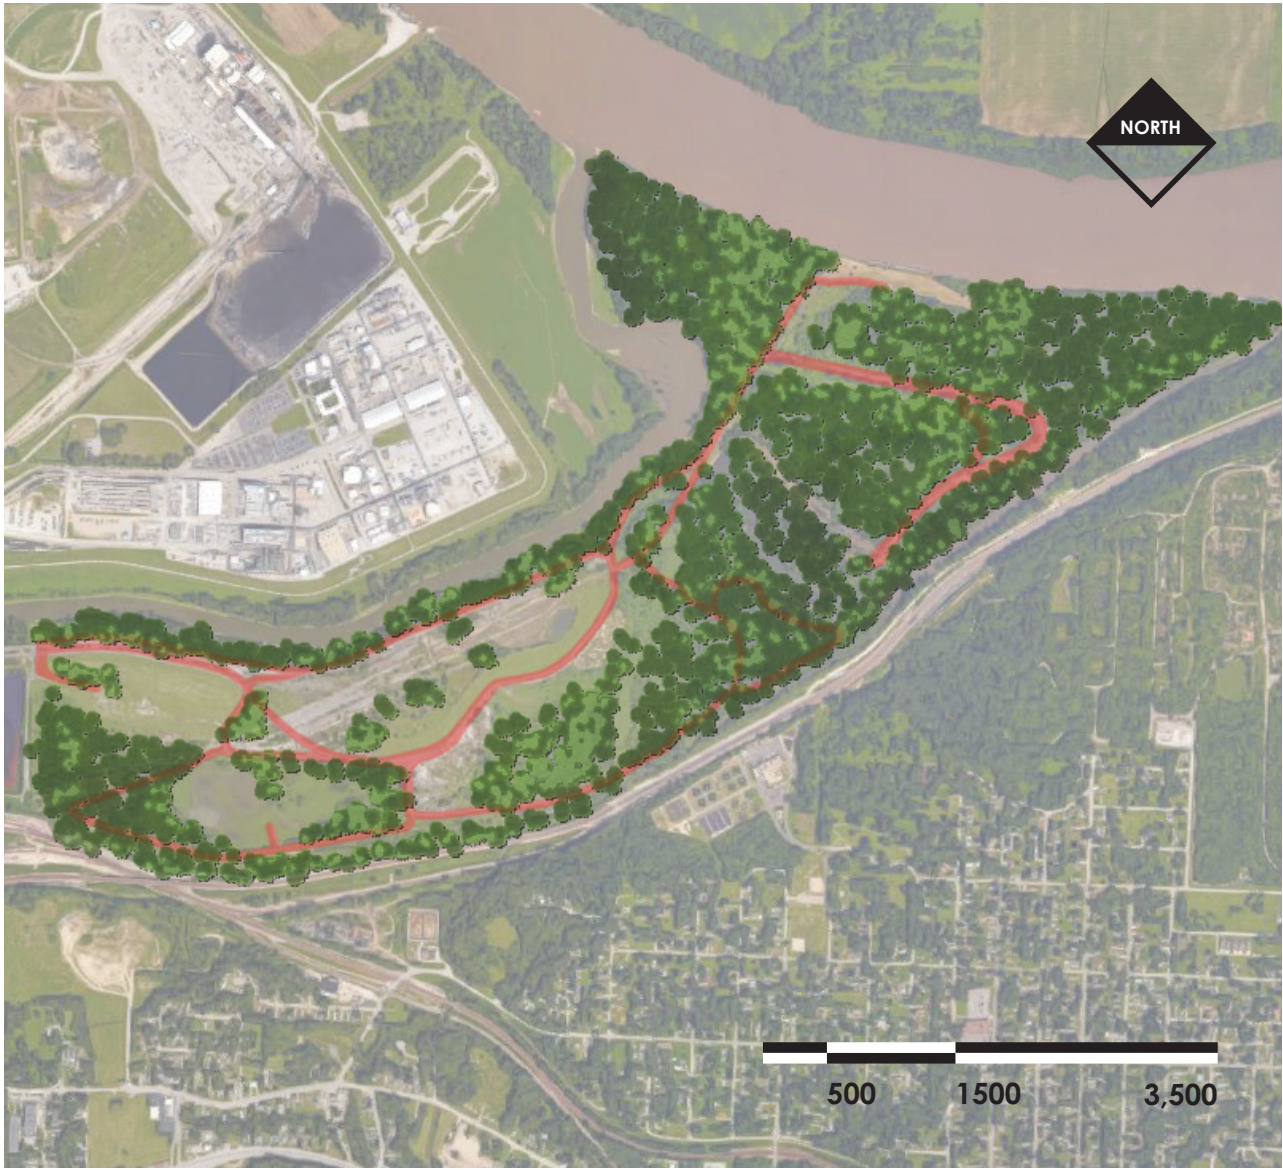
The site's pathways are leftover trucking roads used by ARMCO to move industrial material. Remnant material and construction are seen throughout the site. It is also apparent that the site is used for unsanctioned activities because there are alcohol bottles and other unwanted litter found in almost every area of the site.

- Using the former trucking roads to build a trail system within the site allows for minimal habitat disturbance.
- Some of these areas are already paved or semi-paved, creating a solid foundation for new infrastructure.
- The existing paths already connect a high percentage of the site, creating unique and distinctly different pockets.
- Trail widths are wide enough to accommodate multiple forms of movement.

- Many portions of the pathways are grass or bare soil, which would become unusable during wet conditions without further modification.
- Pathway construction over landfills is restrictive.
- Dense vegetation restricts views on some sections of the pathway.

Fig. 3.71: Existing Paths and Vegetation (Swehla, 2017)

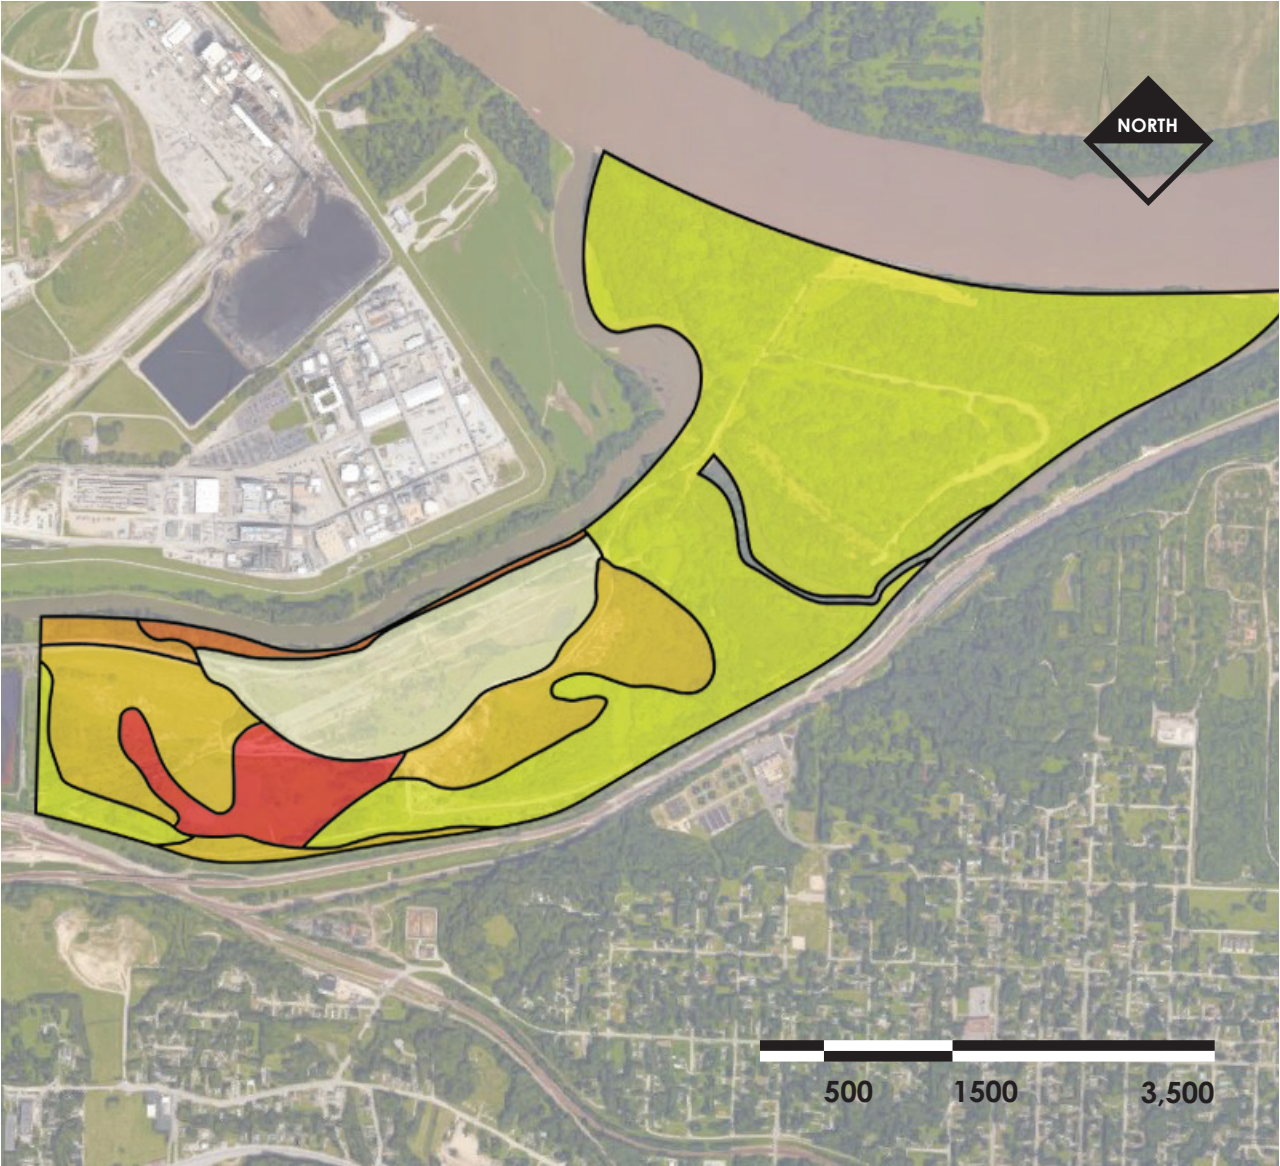
Fig. 3.75: Soil percent Clay (Swehla, 2017)

The amount of clay within a soil zone also affects the type of vegetation that may be grown there. Clay retains moisture well and tends to be more nutrient-rich than other soil types. The reason for this is that the particles that make up clay soil are negatively charged. They attract and pick up positively charged particles, such as calcium, potassium, and magnesium. This means that trees and shrubs grow well in clay, however, the roots of most annuals, perennials, and vegetables
